**Re: Review of Bushfire Risk – Residential subdivision
at Catherine Hill Bay by Coal & Allied and Rose Group**

**Review of the 556 lot residential subdivision
at Catherine Hill Bay by Coal & Allied and Rose Group
on behalf of Catherine Hill Bay Progress Association**

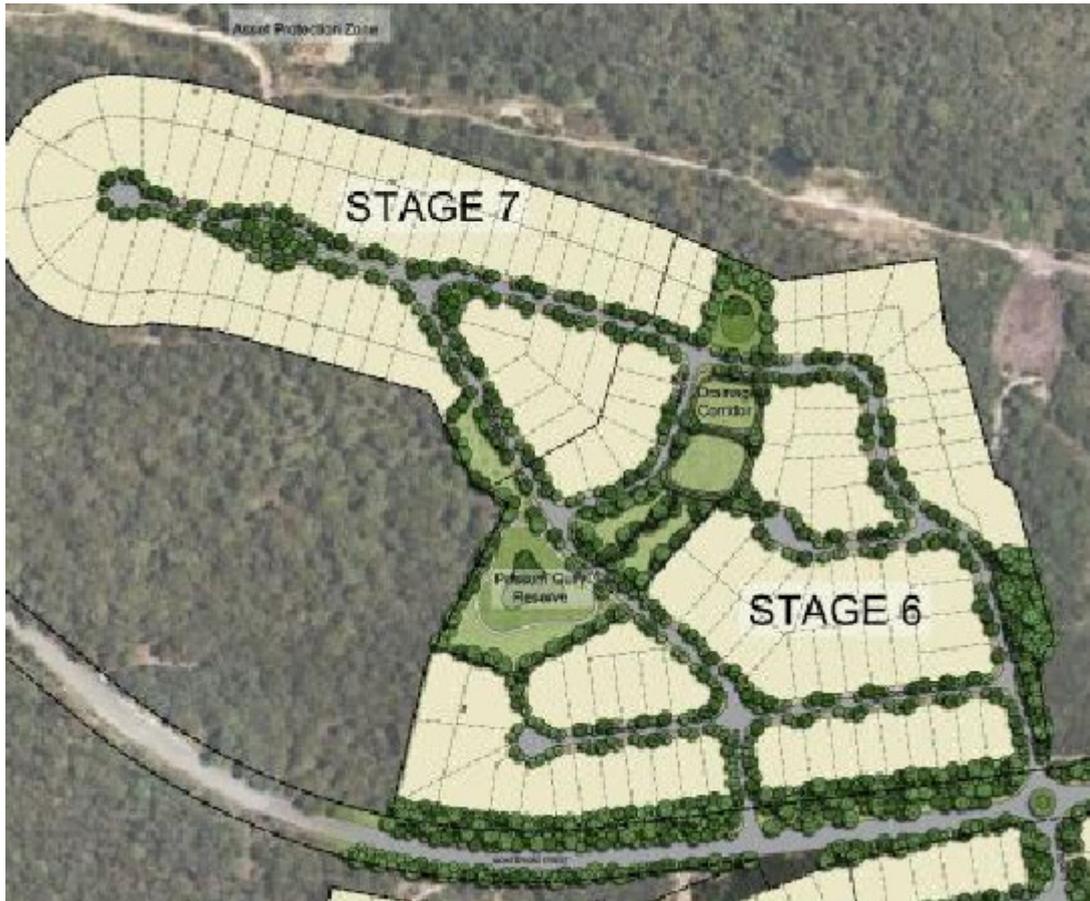
Figure 1 – Zoom in of Stages 6 & 7 (Source; Landscape Plan)

- The table within Section 4.4 of the report and the descriptions of the vegetation within Section 4.2 highlight that Stages 6 & 7 are separated by 'areas of vegetation' and 'Open Forest between the two sections'. (See figure below which was taken from the landscape plan). The table indicates that an APZ of 25 metres is required between the lots within Stages 6 & 7 and the bushland corridor. The accompanying APZ map to the bushfire report however does not show this APZ and the APZ is also not shown on the landscape plan. The landscape plan provides a visual depiction of a managed landscape with planted trees. In my opinion this would not require an APZ to be applied as the design is a default APZ. This inconsistency should be corrected and defined as either an unmanaged bushland corridor that requires an APZ or the land is a managed landscape that does not require an APZ.

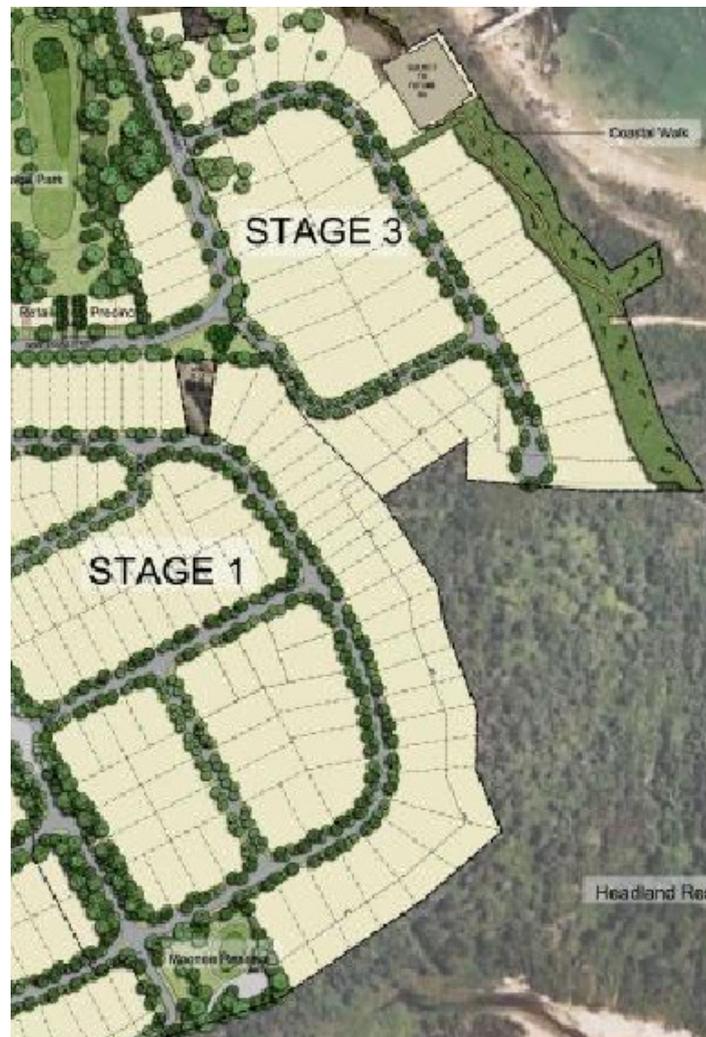
*Figure 2 – Stage 1 and Stage 3.
(Source; Landscape Plan)*

- The subdivision does not provide perimeter roads on all boundaries. For example, perimeter roads are not provided to the east of Stages 1 & 3, west of Stages 6 & 7 or north of Stages 6 & 7 – see Figure 2 and Figure 3 below.

This lack of perimeter protection not only reduces the separation provided between the vegetation and the urban interface, placing residents at an increased risk, but also limits the accessibility of fire fighters to the bushfire front. This affects approximately 90 lots which provide direct frontage to this bushfire prone vegetation.

A fundamental tenant of PBP 2006 is the need for perimeter road access. The bushfire report does not provide reasons for this omission and why the subdivision design should deviate from PBP 2006.

In essence this design places all fuel management within the individual allotments and does not allow effective management of the hazardous fuels. Without this each individual allotment can-not work to protect their neighbor and or vice versa.
